# Installation Restoration Program Phase II — Confirmation/Quantification Stage 1

Homestead Air Force Base Homestead Air Force Base, Florida 33039-5300

March 1986

Final Report 8/84 to 3/86

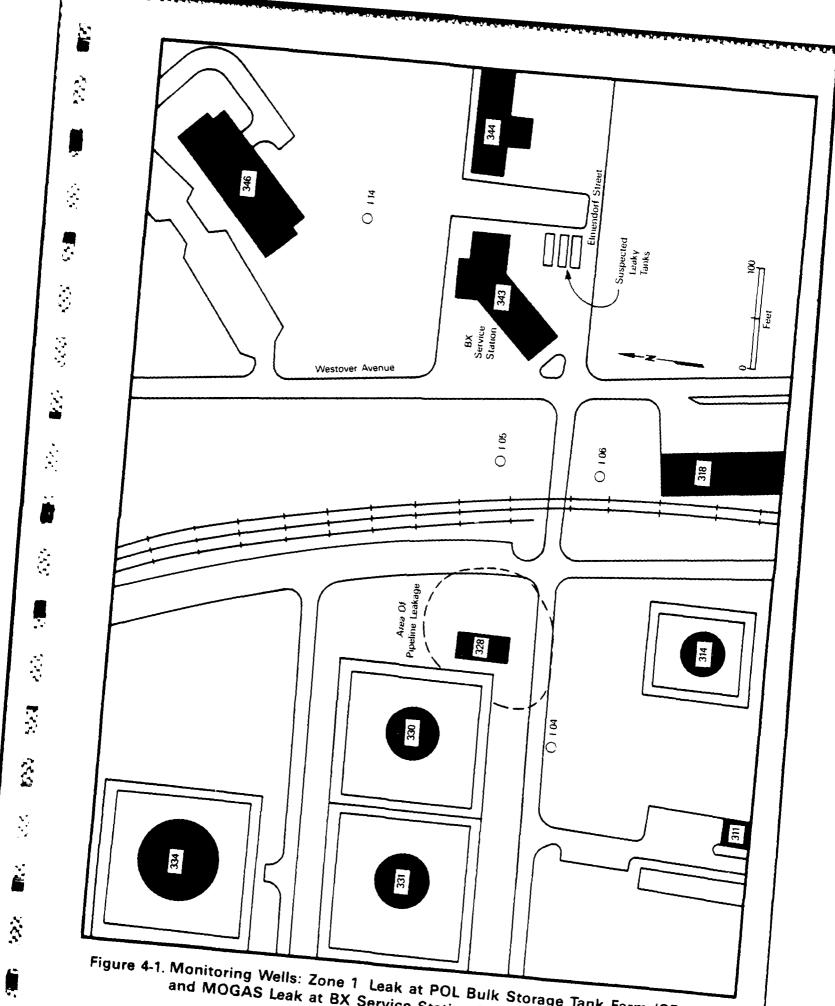
Figure 4-1. Monitoring Wells: Zone 1 Leak at POL Bulk Storage Tank Farm (SP-4) and MOGAS Leak at BX Service Station (SP-6)

Three new groundwater monitoring wells (I-01, I-02, and I-03) were installed and sampled at this site. Four soil and two sediment samples were also collected. Their locations are shown in Figure 4-1, and the analytical results are shown in Tables 4-6 and 4-7, respectively.

Site	Recommendations	Rationale
Zone 1: Leak at POL Bulk Storage Tank Farm (SP-4) and MOGAS Leak at BX Service Station (SP-6)	Resample I-4 and I-14 and analyze for all organic priority pollutants.	To determine specific groundwater contaminants and distinguish between contaminant sources.
	Install 6 additional monitoring wells, sample and analyze for target compound identified in I-4 and I-14 (or for volatile organics using EPA method 624 and for tetraethyl lead).	To determine the extent of groundwater contamination and better define groundwater flow in the area.
Residual Pesticide Disposal Area (P-3)	Install 1 monitoring well, sample and analyze for priority pollutant pesticides.	To confirm or deny pesticide contamination in groundwater.
	Collect 10 soil samples and analyze using the stage 1 17-analyte pesticide scan.	To delineate the areal extent of soil contamination.
Fire Protection Training Area No. 3 (FPTA-3)	Resample I-12 and analyze for all organic priority pollutants.	To determire specific groundwater contaminants.

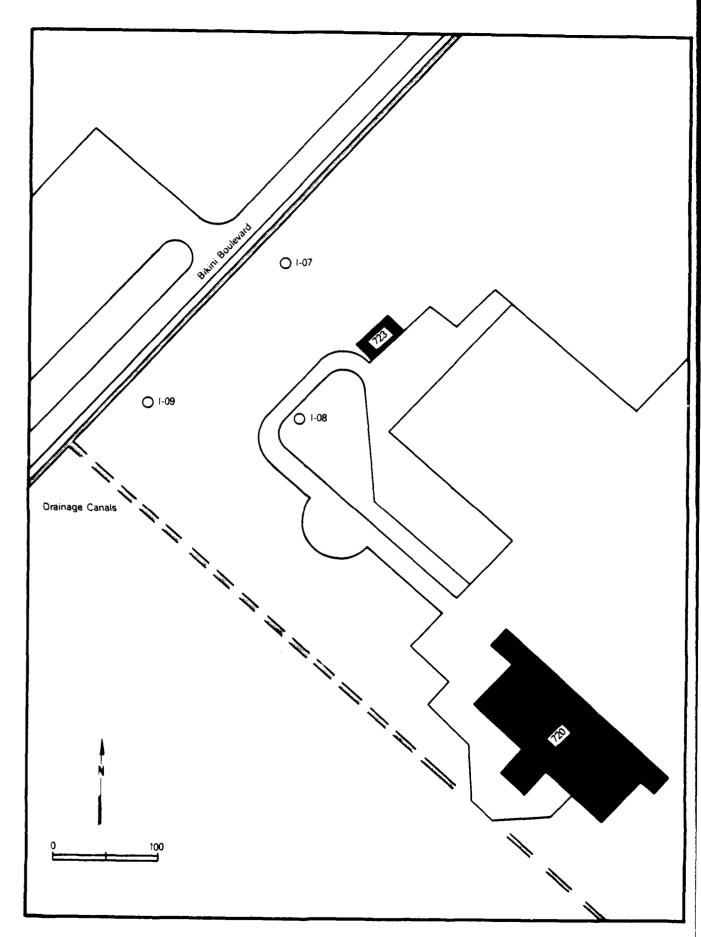
Three new groundwater monitoring wells (I-07, I-08, and I-09) were installed around this site, as shown in Figure 4-3. The results of the oil and grease, TOX, and TOC analyses are shown in Table 4-9. These results can be summarized as follows:

- Oil and Grease: significant levels (>1 mg/l [ppm]) found in only one well (I-09), but this well is so contaminated that the sample separated into two fractions. The partially diluted, floating fraction had 732,000 mg/l (ppm) (73.2 percent) oil and grease, while the water fraction had 6.49 mg/l (ppm)
- TOX: no significant contamination found
- TOC: significant contamination found in all three wells, with I-08 having the highest.

These data show gross contamination in all three wells, so the boundaries of the contamination plume are unknown. A body of floating contaminants exists in the vicinity of Well I-09. This contamination appears to be primarily oil and fuel related, with no significant evidence of chlorinated organic solvents, as indicated by the insignificant TOX levels.

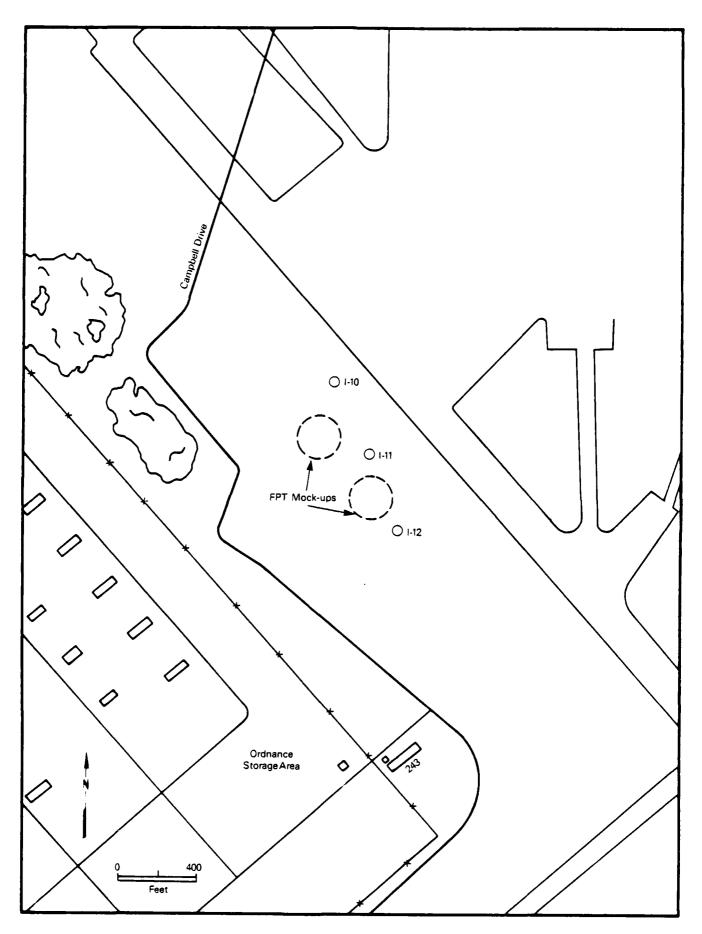
Figure 4-4. Monitoring Wells: Fire Protection Training Area No. 3 (FPTA-3)

These data show that the site is quite contaminated with fuel (in the vicinity of I-12), non-specified organic carbons, and fire fighting foam, the presence of the latter based on visual evidence of foaming seen during well development and purging and on TOC levels. Because all of the wells show contamination, the plume boundaries are not definable at this stage.

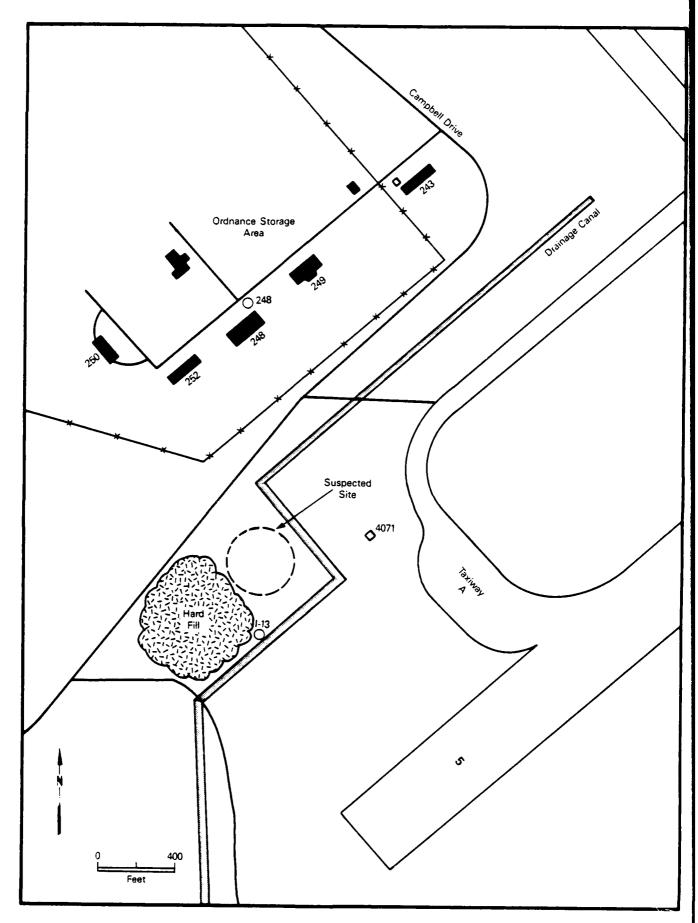
One new groundwater monitoring well (I-13) was installed to the southeast (downgradient) of the suspected location of this site. This well, and a fire fighting supply well (termed Well 248) located just northwest of Building 248 within the Ordnance Storage Area, were sampled for oil and grease, TOX, and TOC. These wells and the suspected site location are shown in Figure 4-5. The analytical results are shown in Table 4-11. These results can be summarized as follows:

- Oil and Grease: no significant levels found
- TOX: significant levels found only in the downgradient well (I-13)
- TOC: levels found in the downgradient well (I-13) are elevated over the upgradient well (248) but are below AWQC; not considered significant.

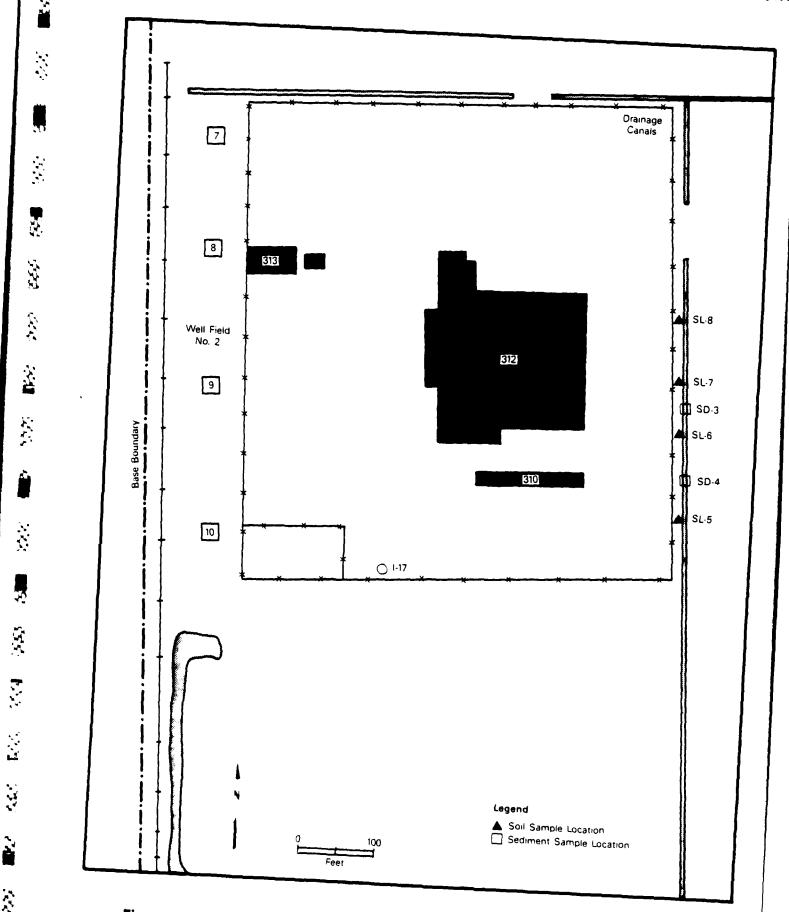
Figure 4-7. Sampling Locations: Oil Leakage Behind Motor Pool (SP-2)

All of the soil and sediment samples collected just outside the east fence of the Motor Pool compound were contaminated with significant amounts of oil and grease and lead. Well I-17, drilled south-southwest of Building 312, was not contaminated. However, based on the Stage 1 data, there appears to be no measurable component of groundwater flow in the direction of Well Field No. 2. Because groundwater flow is in an easterly direction, Well I-17 is not in a location to intercept groundwater contamination resulting from spills or leaks within the compound. Moreover, the extremely high oil and grease values

in soils adjacent to the canal and in sediment within the canal, in conjunction with a strong interconnection between surface water and groundwater, indicate that shallow groundwater just east or southeast of the compound is contaminated.

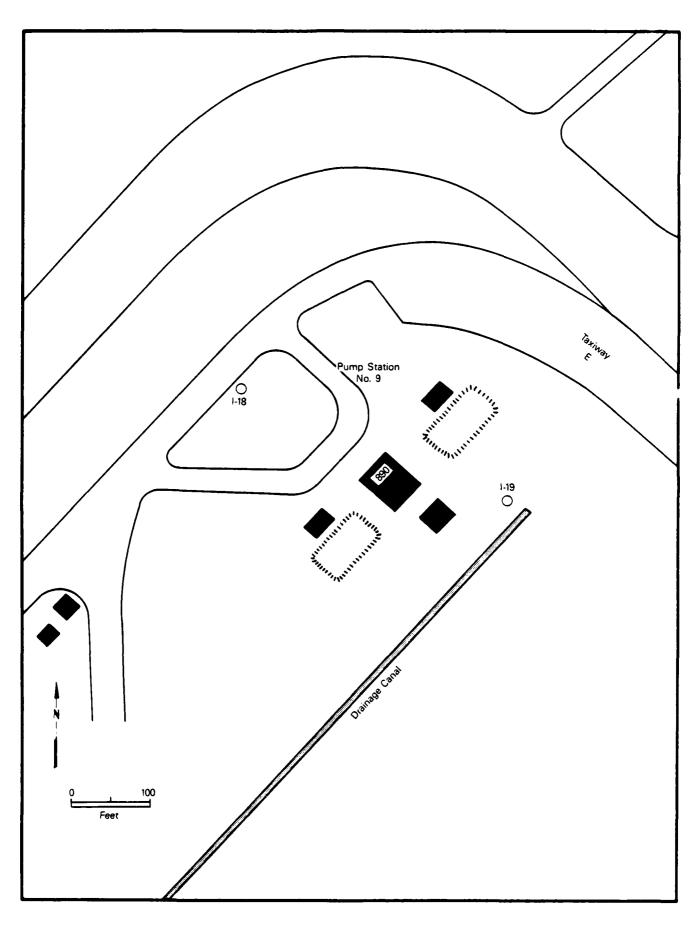
Figure 4-8. Monitoring Wells: Leak at Pump Station No. 9 (SP-5)

Two new groundwater monitoring wells (I-18 and I-19) were installed at this site, as shown in Figure 4-8. Both wells were sampled for TOX and TOC, and only Well I-19 was sampled for oil and grease. Well I-18 was not sampled for oil and grease because six-tenths of a foot of fuel was found floating on the groundwater at this location. A sample of this fuel was collected by the base Bioenvironmental Engineer and sent to the Energy Management Laboratory at MacDill AFB, Florida, for analysis. The results of the groundwater analyses are shown in Table 4-15. The fuel analysis is summarized in Table 4-16. The USAF Energy Management Laboratory report

The second goal can be met by sampling the groundwater below the fuel in Well I-18 and analyzing for all Priority Pollutants. This strategy will allow for a determination of all contaminants in groundwater at the site, whether or not they are directly related to the JP-4 leaks.

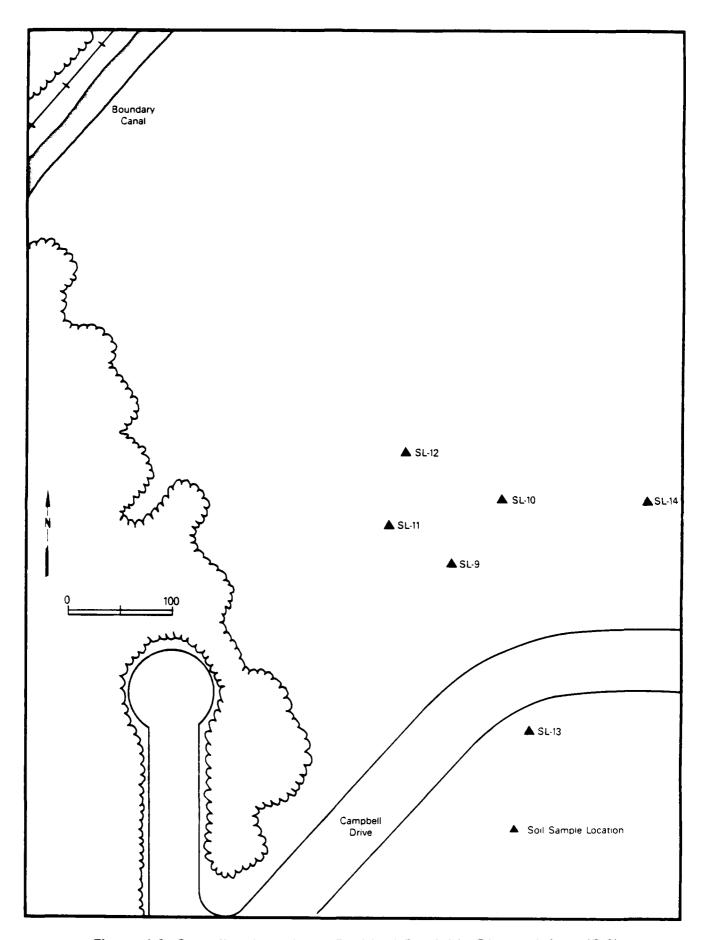
Figure 4-9. Sampling Locations: Residual Pesticide Disposal Area (P-3)

Five of the 17 pesticide analytes were detected in these samples. Only one, SL-13, had no pesticides detected. The compounds detected are all organochlorine insecticides of extremely low solubility in water. Consequently, all have great affinity for soil (high adsorption coefficients), reducing their potential for percolating down into the groundwater. These insecticides are all persistent compounds, degraded only after many years in the soil. If they are allowed to enter the groundwater, where degradation is far slower than in soil, they may persist indefinitely. According to Entomology Shop personnel (conversation, 11/84) pesticides were poured on the ground at this site (not just sprayed as indicated in the Phase I Report), therefore, there is a strong possibility that the more mobile compounds have entered the groundwater. Even the low solubility compounds found in soils here could have contaminated the groundwater if applied (poured) in sufficient amounts, given the thin soil and the shallow groundwater in the area.

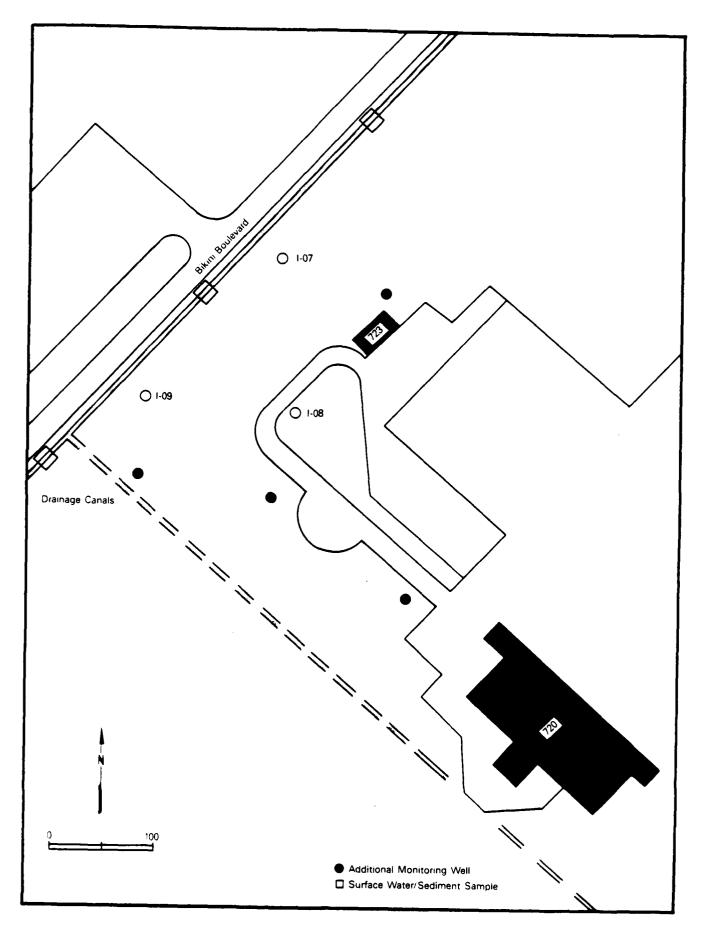
Figure 6-2. Recommended Monitoring: SP-7

The third goal, assessing surface water contamination, can be met by collecting water and associated sediment samples from the canal that runs between the site and Bikini Blvd. It is recommended that samples be collected at four locations, as shown in Figure 6-2. These samples of both water and sediments should be analyzed for volatile organics by EPA Method 624. These resulting data will allow for an assessment of this pathway by determining if significant contamination is present and determining the partitioning of contaminants between the water and sediments.

The second goal, determining the extent of groundwater contamination, will require the installation of additional monitoring wells. It is recommended that a soil gas survey be conducted to delineate the extent of contamination and that four additional wells, as illustrated in Figure 6-2, be installed and sampled along with the Stage 1 wells. Analysis of these samples for volatile organics should be accomplished by EPA method 624. Based on our current understanding of the contaminants and the site setting, this approach should be suitable for determining the nature and extent of contamination.

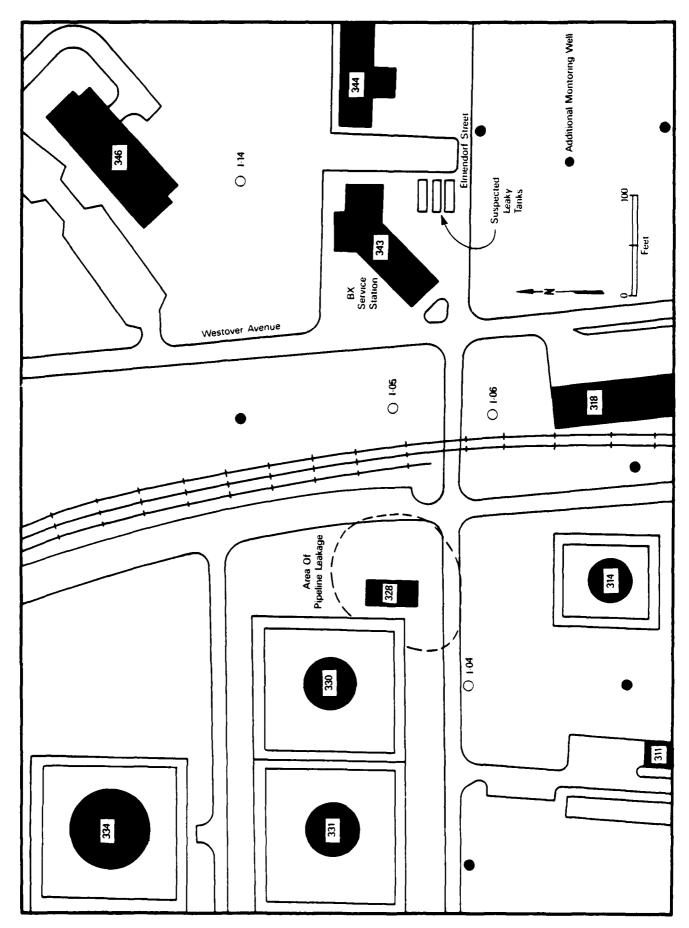
Figure 6-3. Recommended Monitoring: Zone 1

Stage 1 results for the two sites in this zone show significant, apparently fuel-related, groundwater contamination throughout this area. All four Stage 1 wells were found to be contaminated, but both the pattern of

Meeting of the third goal will require soil gas mapping of the entire zone and the installation of at least six additional monitoring wells approximately as illustrated in Figure 6-3. This monitoring network (including Stage 1 wells) will be more capable of determining the extent of groundwater contamination, and will provide a much better characterization and perhaps an explanation for the groundwater low and corresponding high specific conductance in the zone. If no specific target analyses are identified beforehand, these groundwater samples should undergo analysis for volatile organics using EPA Method 624 and tetraethyl lead. This last analyte is needed to distinguish leaded MOGAS contamination.

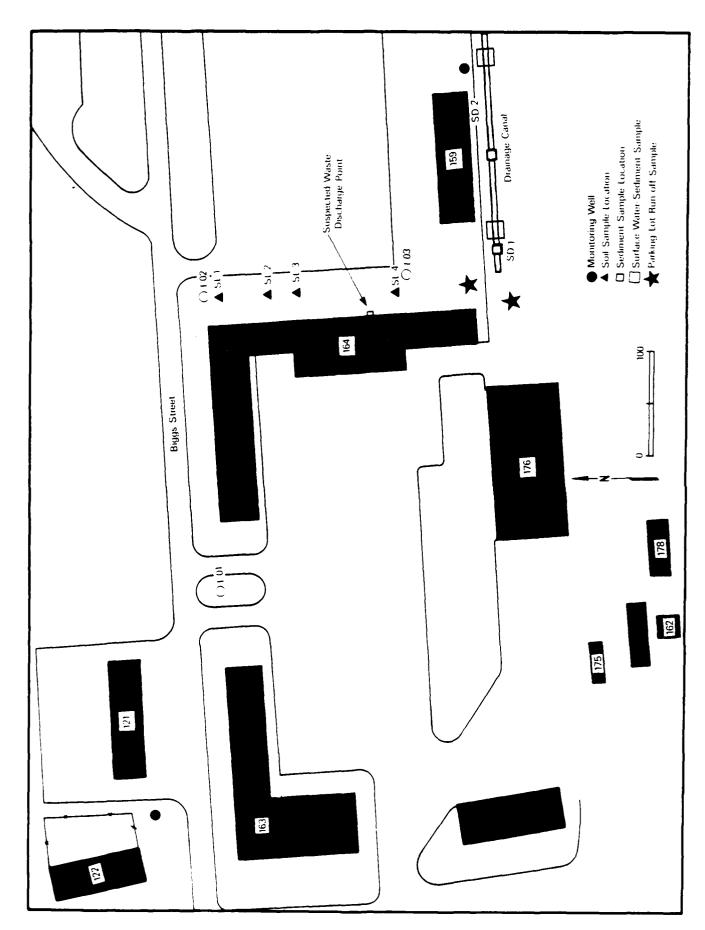
Figure 6-8. Recommended Monitoring: SP-1

Because the levels of inorganic contaminants downgradient of this site are close to the range of background levels taken from the literature, the three Stage 1 wells should be resampled with analysis for the Stage 1 parameters. Analysis of these results and comparison with Stage 1 results will allow for a determination of the statistical significance of the elevated

level of inorganics and allow for a more confident appraisal of the environmental impact of this site. In addition, two additional wells should be installed as indicated in Figure 6-8 and sampled in an identical manner to the Stage 1 wells.
